Manhole Inspection Summary

Manhole # S33E__030MH

Insp Date: **8/5/08 9:14 AM**

Location Address: **rear 300 w fayette st**

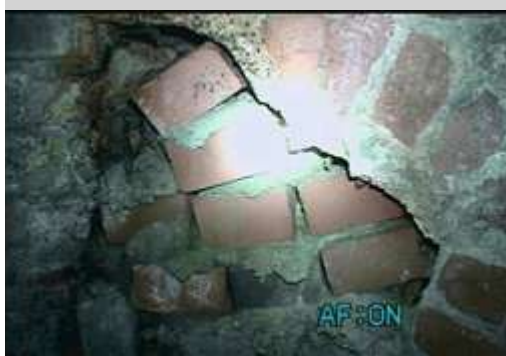
Defect 3

Condition: ☐ Sound ☒ **Cracked** ☐ Root Intrusion ☒ **Loose Brick** ☒ **Deteriorated**

barrel cracked, loose bricks, deteriorated

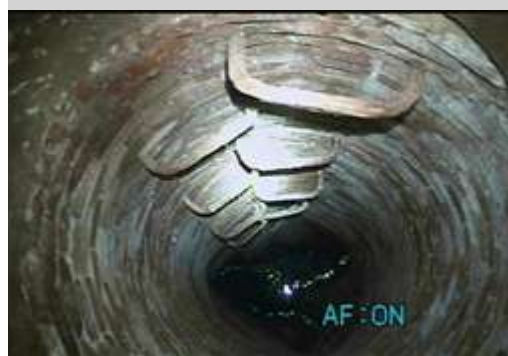
Defect 2

Count: **11** Missing: **0** ☒ **Corroded**

steps

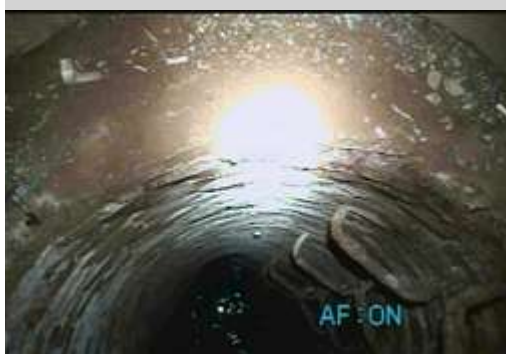
Defect 1

Offset: **8** (in.)

offset
